National Transportation Safety Board

DCA22WA102

COCKPIT VOICE AND FLIGHT DATA RECORDER

Combined Download Report
July 1, 2022

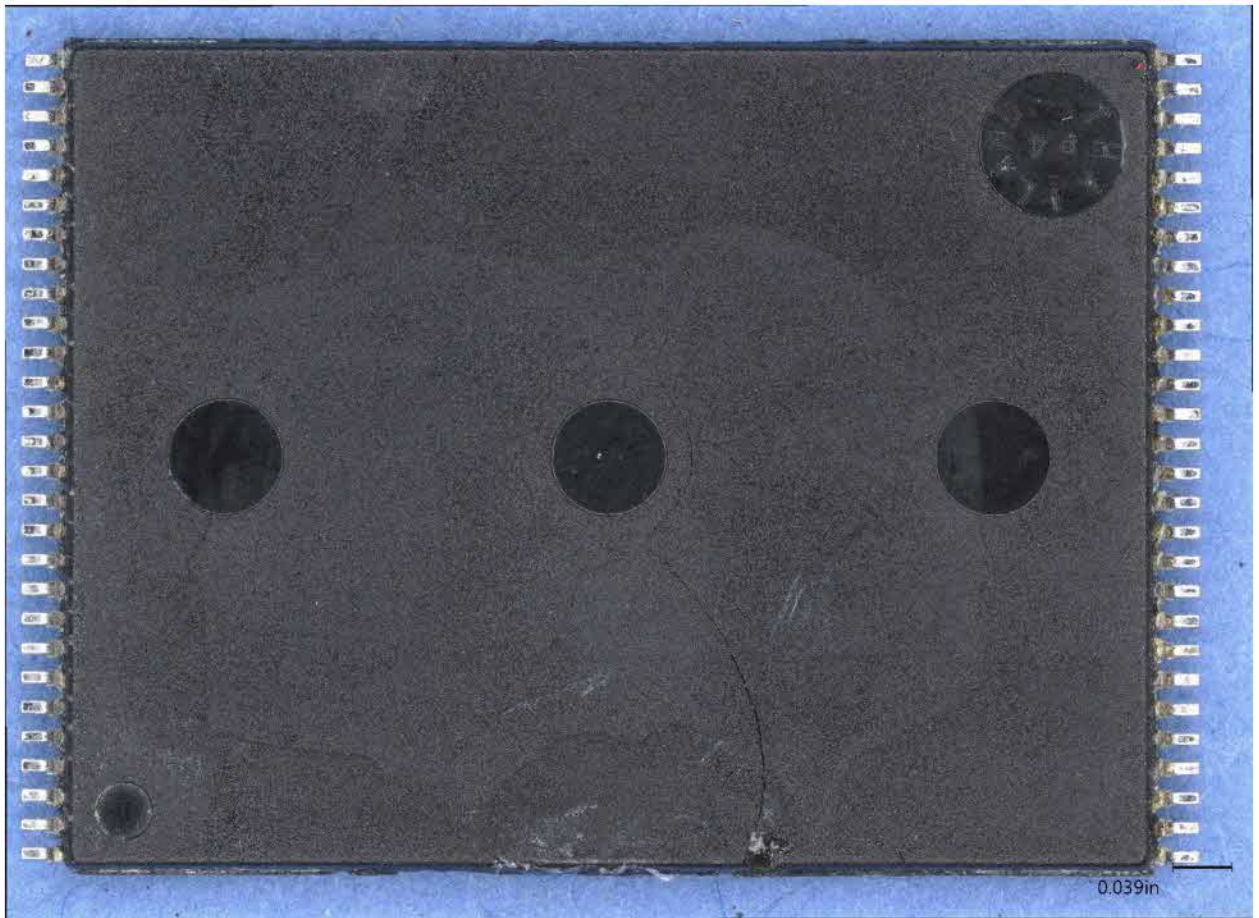
An inspection of chip U2 (the chip with the visible crack in the packaging) identified a network of cracks on the bottom of the chip in addition to the previously observed crack. The other chips did not reveal additional damage when they were removed from the board. Figure 10 shows the bottom of chip U2 following removal from the board.

Figure 10. Bottom side of chip U2 showing cracks throughout chip packaging.

The chips were read in the Xeltec memory reader and the resulting binary images for chips U1, U3, U4, U5, and U6 were found to contain data. Chip U2 could not be read and the Xeltec reported numerous pin-check errors and messages indicating that many of the pins were shorted. This was a sign of significant internal damage to the silicon die within the chip itself.

Chip U2 was X-rayed and CT scanned, and chip U4 was also X-rayed as an exemplar. The results of the CT scan were noisy and revealed no new information. Some of the cracks identified visually on the bottom side of the packaging were apparent in the 2-D X-ray images. These cracks passed through the region of the chip housing the silicon die containing all the internal circuitry. Several other of the undersurface cracks were not visible in the X-ray because they appeared to follow the outline of the X-shaped copper die pad upon which the silicon die was bonded during manufacture of the chip. This extreme damage rendered any data from U2 unrecoverable.

A dummy file of all hexadecimal 'FF' (binary '1') was created and used in place of the image from U2 in the Honeywell CHIPS utility to create a FDR DLU file. The resultant DLU file was then imported into the NTSB CIDER data analysis application. The data was framed out with information provided by the aircraft manufacturer.

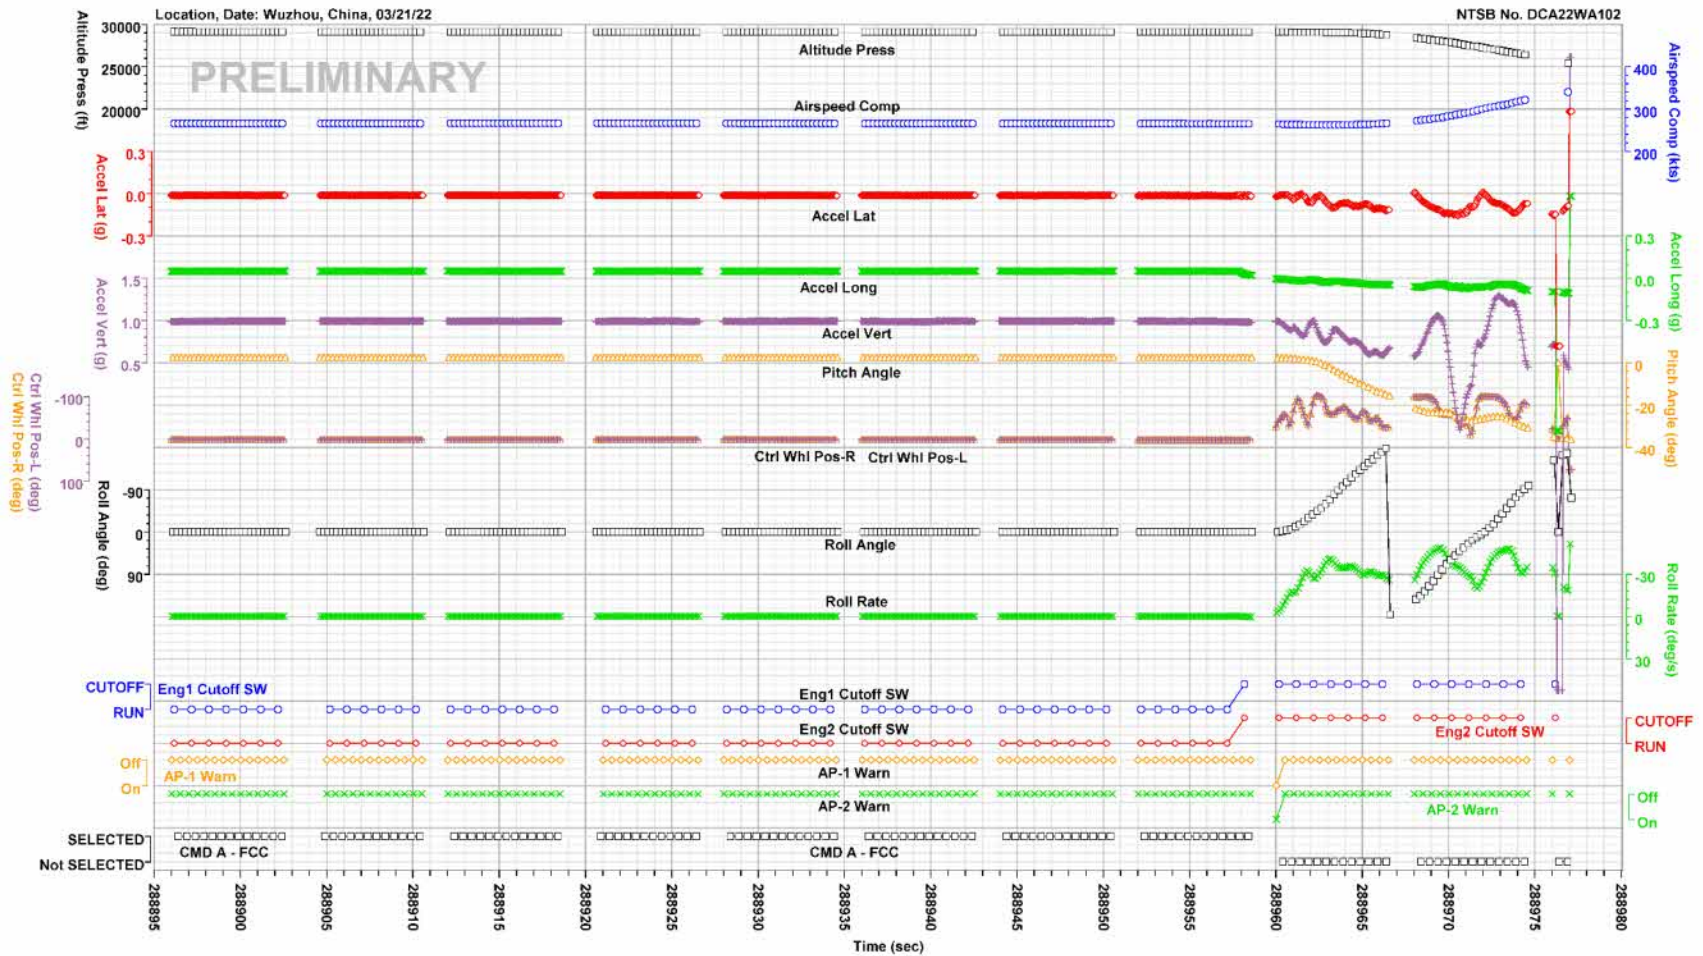
Figure 11. Basic aircraft parameters from final 90 seconds of recording.

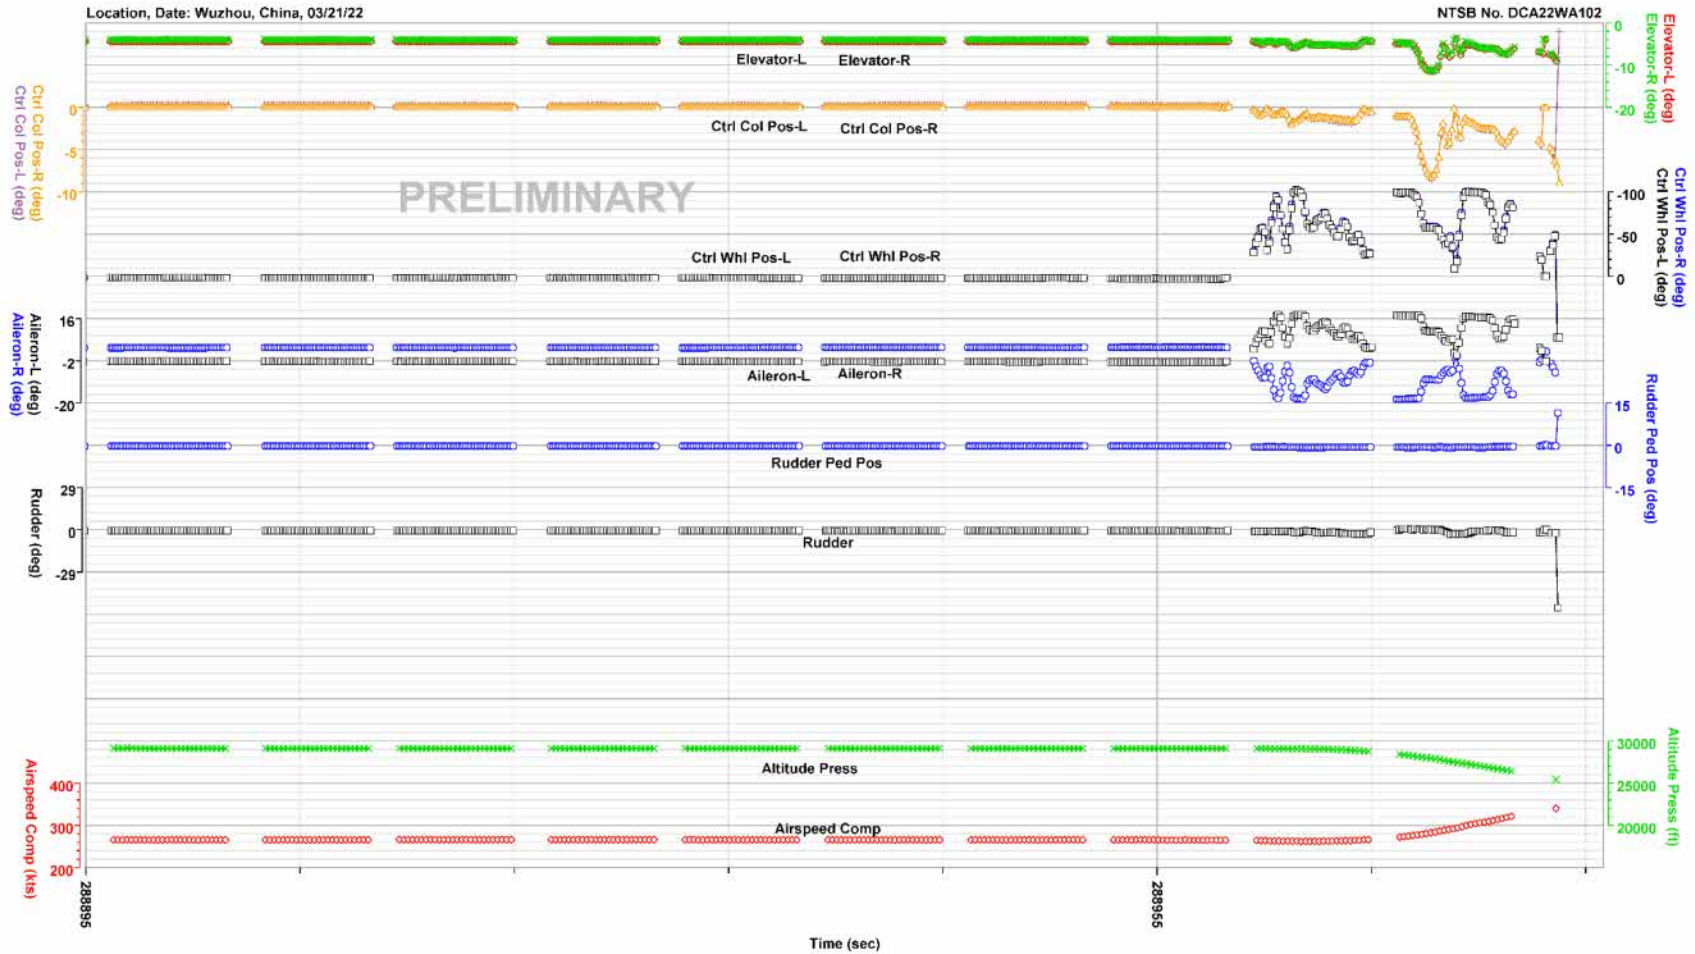
Figure 12. Flight control and input positions for final 90 seconds of recording.
